CRITICAL CARE UNIT  
IBN AL BITAR HOSPITAL  
BAGHDAD, IRAQ

**SIGIR-PA-06-066**  
**SEPTEMBER 12, 2006**

SUBJECT: Report on Project Assessment of the Critical Care Unit at the Ibn Al Hospital,  
Baghdad Iraq (Report Number SIGIR-PA-06-066)

## **Critical Care Unit, Ibn Al Bitar Hospital Baghdad, Iraq**

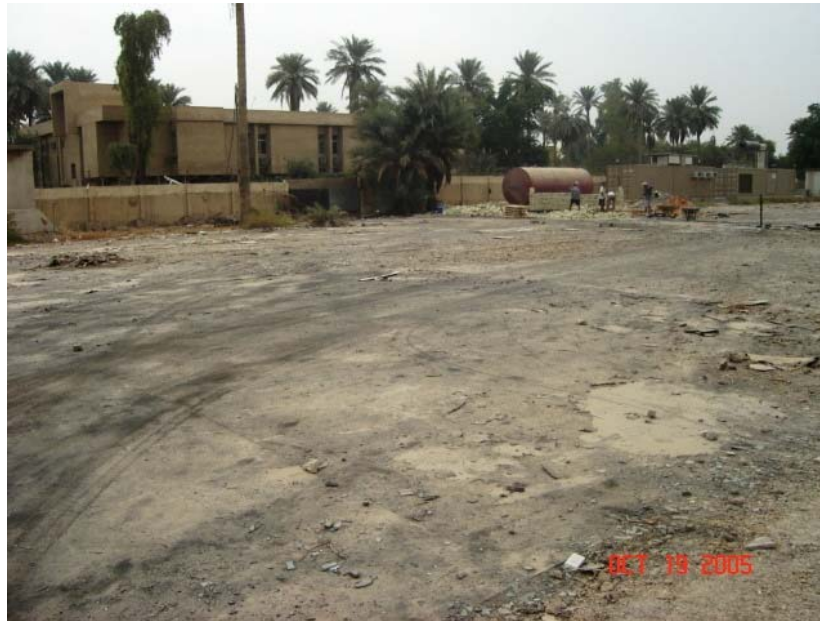
concrete slab remaining. Site Photo 1 shows the clinic site and parts of the ground floor concrete slab.

**Site Photo 1. Old and new site of the Ibn Al Bitar  
Hospital Cardiac Care Unit (Photo provided by USACE)**

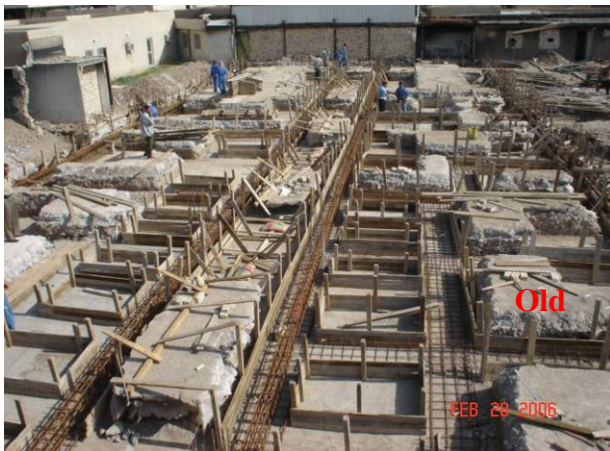
**Site Photo 2 - Wall footings and tie beams under construction (Photo provided by USACE)**

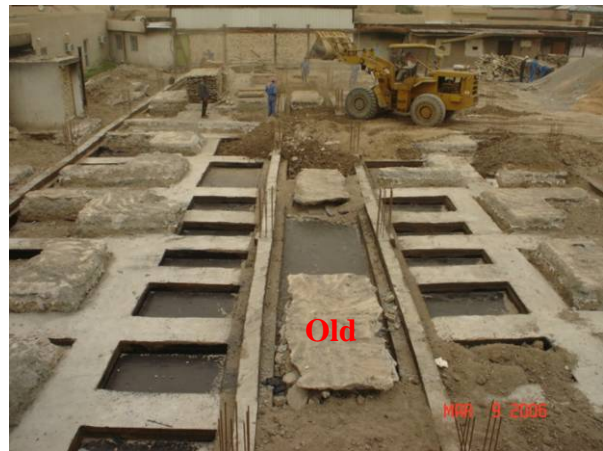
**Site Photo 3 - Completed wall footings and tie-beams (Photo provided by USACE)**

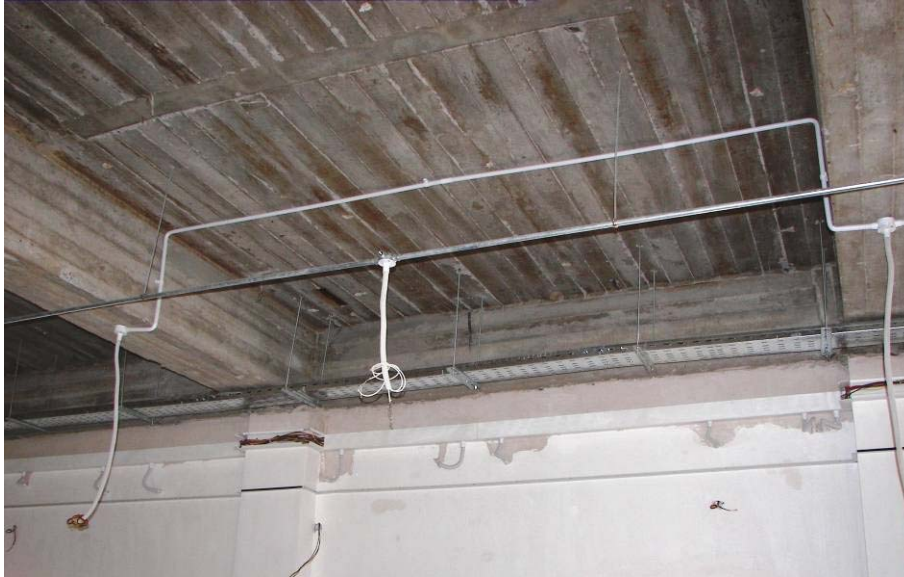
At the time of the site visit, the suspended ceiling had not been completely installed so the assessment team could see the upper portions of the ground floor columns and beams. We did not observe any noticeable defects with the concrete workmanship such as honeycombing, segregation, or exposed reinforcing steel. Site Photo 4 shows some of the structural concrete work at the CCU.

**Site Photo 4. Structural concrete supporting the first floor**

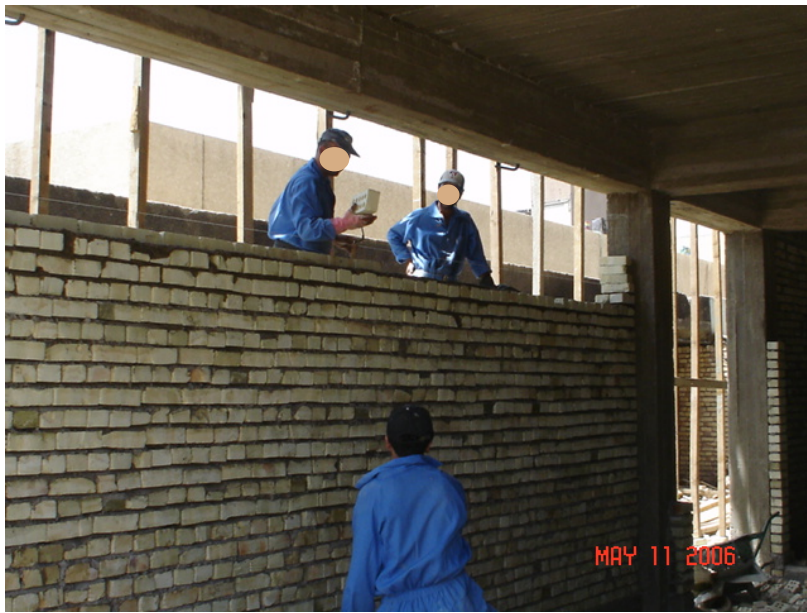
**Site Photo 5. Exterior wall brick work (Photo provided by USACE)**

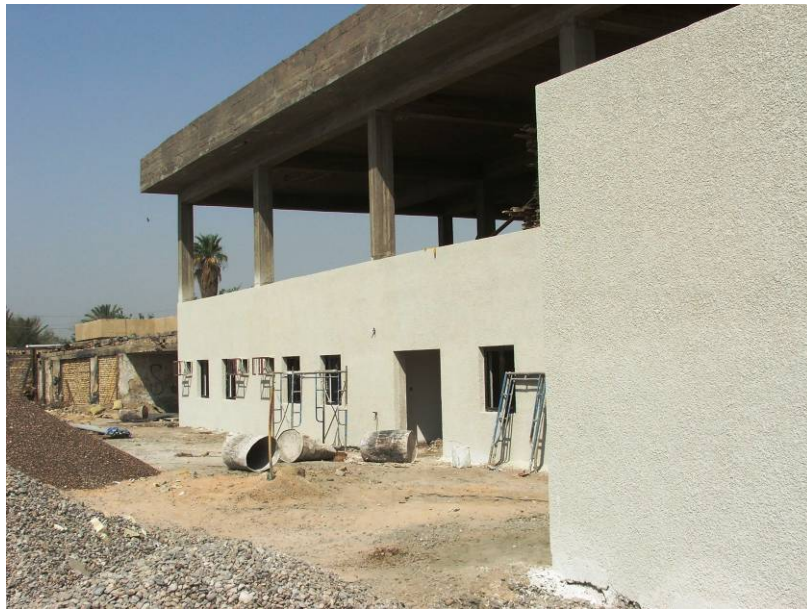
**Site Photo 6. Exterior walls of the CCU after plastering and rendering.**

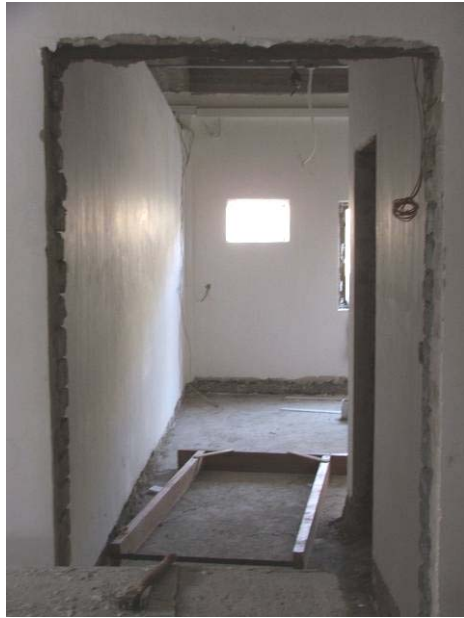
**Site Photo 7. Patient room looking from entrance**

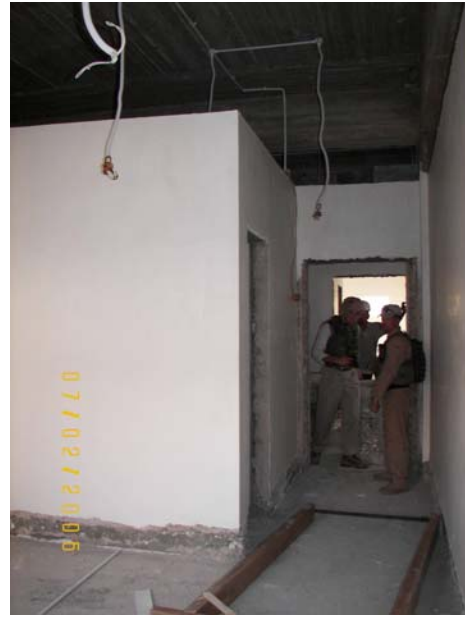
**Site Photo 8. Patient room looking towards entrance**

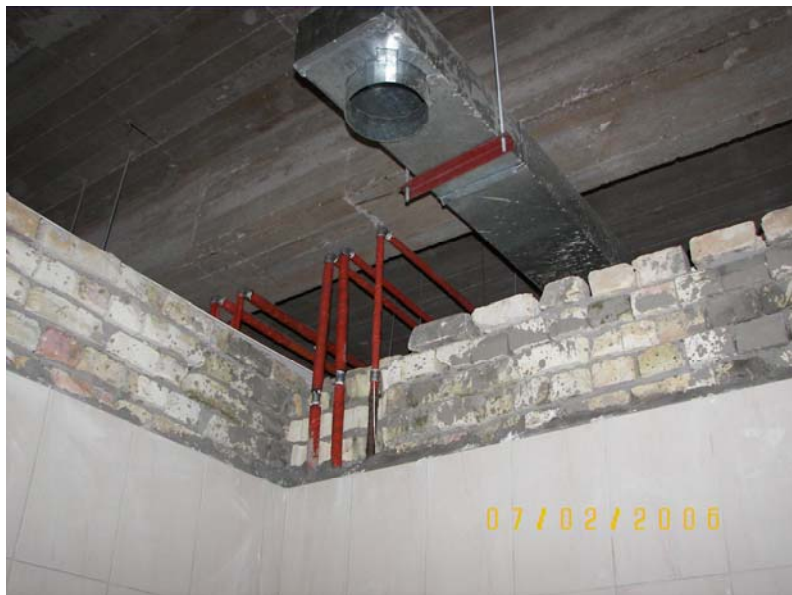
**Site Photo 9. Water lines and exhaust system ductwork above one of the patient bathrooms**

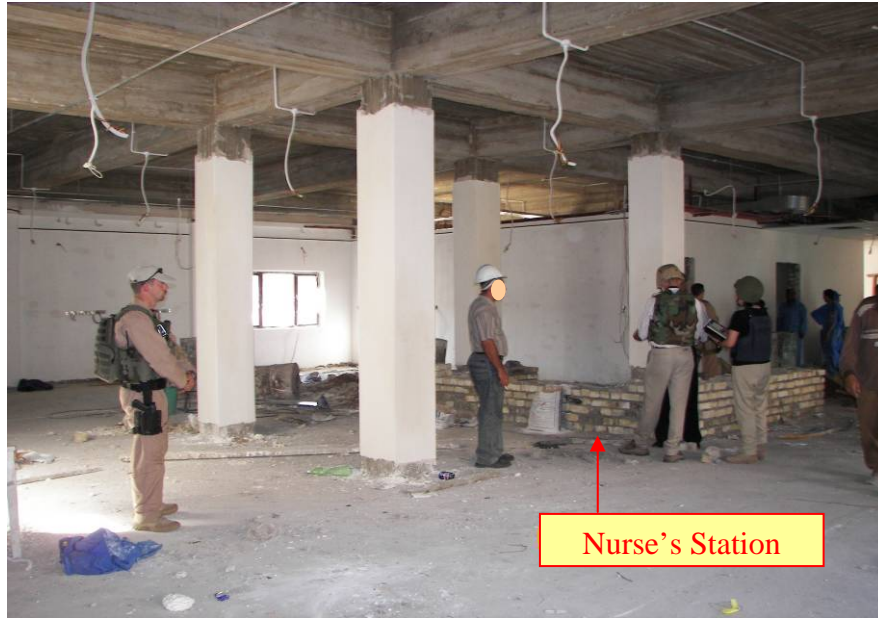
At the time of our assessment, the contractor had completed plastering and painting the exterior walls. Aluminum window frames were installed. Electrical conduits were in place, and the contractor was in the process of pulling wire to recessed boxes for outlets and switches. Site Photo 10 shows part of the open ward observed during the site visit.

**Site Photo 10. Ward area under construction.**

In addition to the building components, the contractor was also constructing a brick reception table base (Site Photo 10) for the nurse's station in the open ward area. The BOQ required a ceramic tile finish for the table.

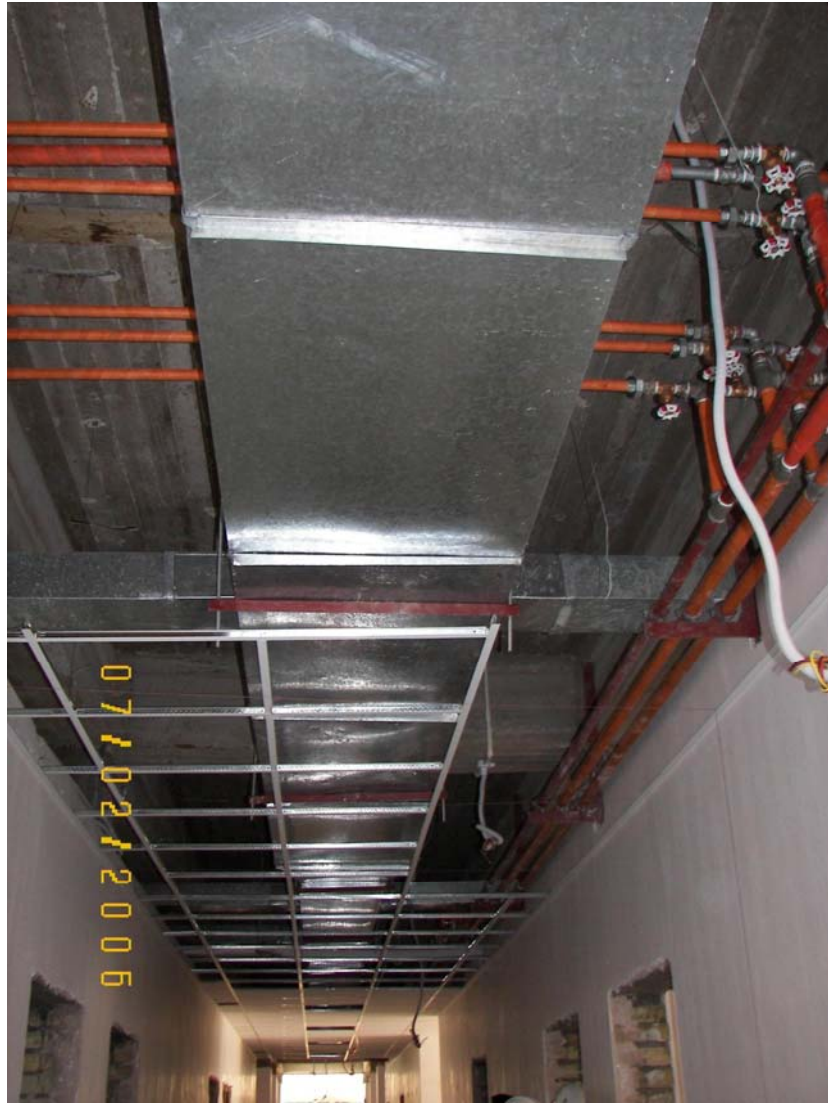
The CCU contained a central corridor (21.6 m in length) providing access to the patient rooms and the ward area. The corridor also provided an access way for the utilities (water, exhaust, and electric), located above the suspended ceiling. Site Photo 11 shows the water lines, the exhaust system ductwork, and the electrical drops installed by the contractor, as well as part of the suspended ceiling grid. The water supply system consists of three lines of various diameters [15 – 50 millimeters (mm)] of schedule 40 galvanized steel pipes for cold water, hot water, and re-circulated hot water. No noticeable defects were found with the installation of these utilities and the quality of workmanship appeared adequate.

**Site Photo 11. Utility installation above corridor suspended ceiling.**

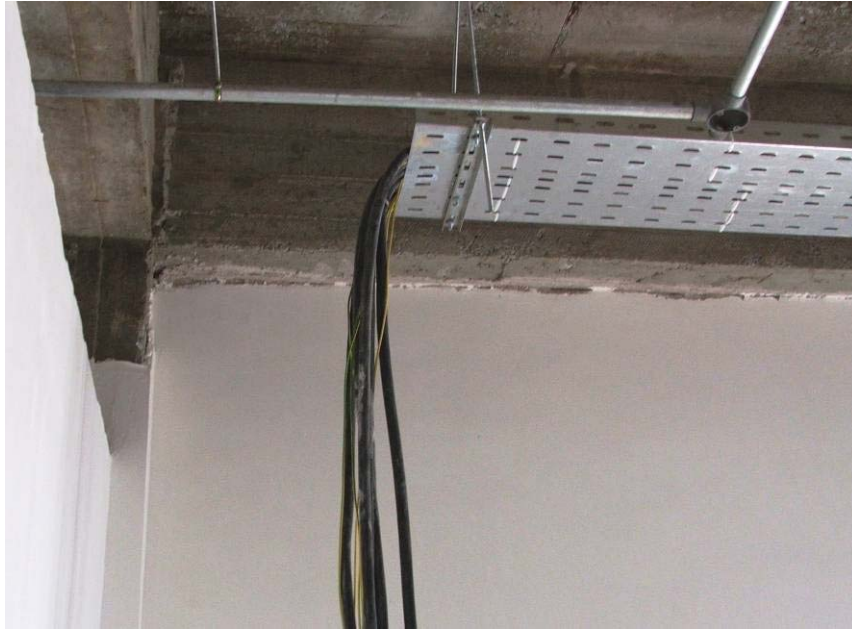
The design included an interior electric room. However, the electrical drawings provided to the assessment team did not show the location of the main electrical distribution panel and two sub-distribution panels that were listed in the BOQ. When we inspected the electrical room, the walls in the room were plastered and painted. The aluminum cable tray was installed and anchored to the concrete slab above the room. One of the contractor's employees indicated to us the location of the main distribution panel inside the electrical room. The contractor was running cable on the cable tray to the panel location as shown in Site Photo 12.

**Site Photo 12. Cable tray and cable to connect the main distribution panel.**

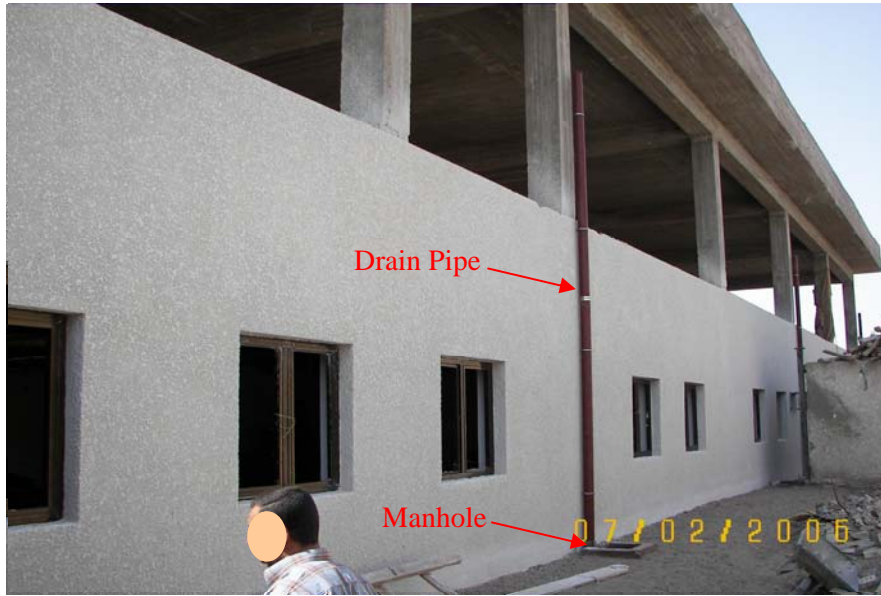
The BOQ listed a requirement for 80 linear meters of 100 mm (diameter) cast iron downspouts. The architectural drawings show the location of the seven roof drains along the column lines for the building. During the exterior inspection, we observed the cast iron downspouts in the locations noted on the design along the column line. We also noted the downspouts drained directly into the manholes, as shown in Site Photo 13, although the design drawings did not provide details showing the downspouts or connections into manholes.

**Site Photo 13. CCU exterior with downspout feeding into sewer manhole.**

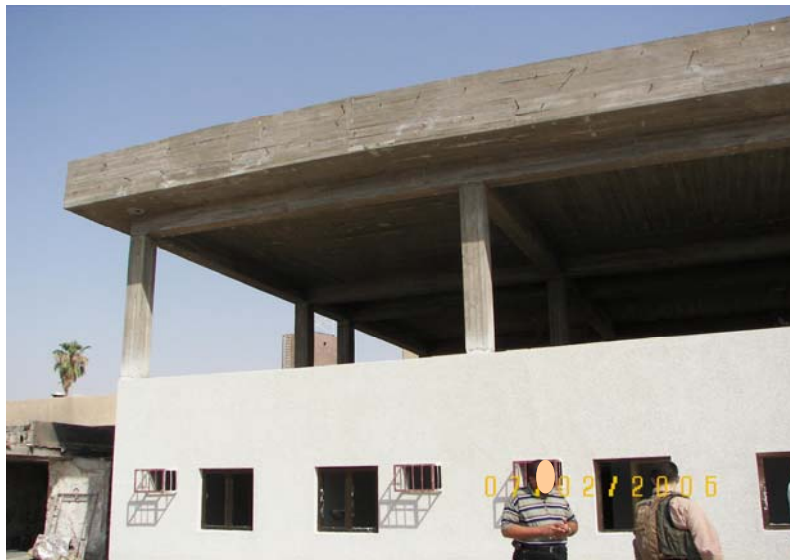
The assessment team planned to inspect the first floor and roof. However, because of recent activity in this area of Baghdad, security concerns prevented the team from going up to the first floor and to the roof. From the ground, we did walk around the building and looked at the exterior columns and beams of the first floor and roof parapet. We did not observe any noticeable defects associated with the concrete workmanship. Site Photo 14 shows the first floor and roof structural concrete work.

**Site Photo 14. First floor columns and beams supporting roof**
